CONNECTORS TROUBLESHOOTING MANUAL

CONNECTORS DIAGRAM

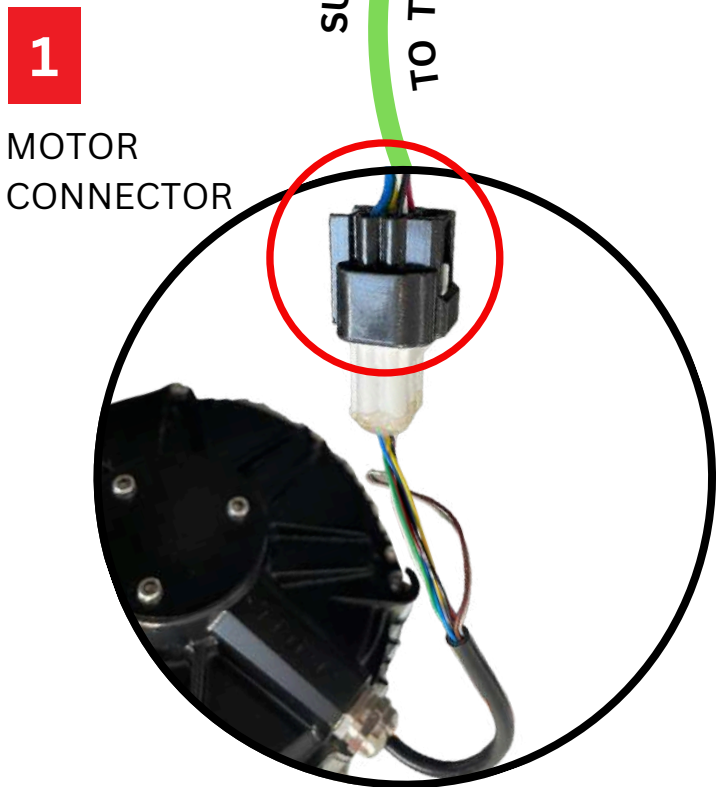
SURRON WIRING HARNESS
TO TORP WIRING HARNESS

A green arrow points from the motor connector towards the top-right diagram.

There are 3 connectors to examine between the motor and the controller, if you're having issues with **temperature, or hall/encoder**. See [page 2-4](#).

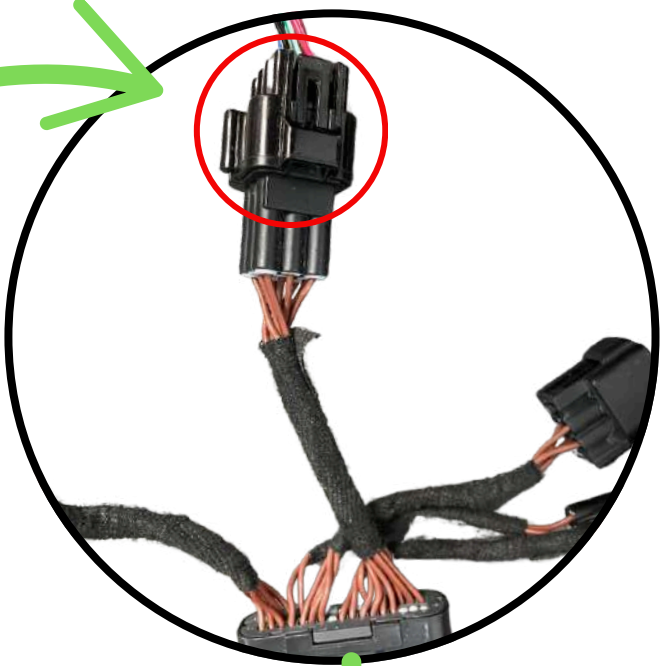
2 9-PIN
CONNECTOR

TORP WIRING
HARNESS TO
TORP MAIN
CONNECTOR

A green arrow points from the 9-pin connector towards the bottom-right diagram.

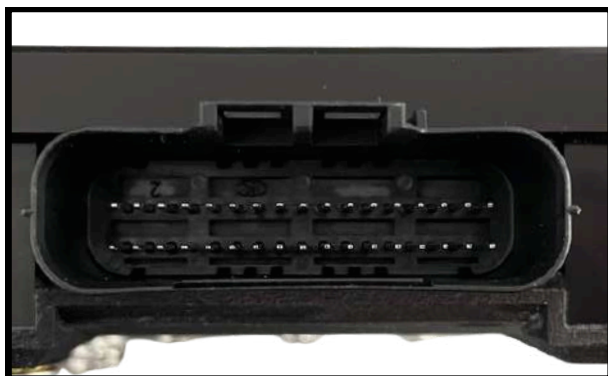
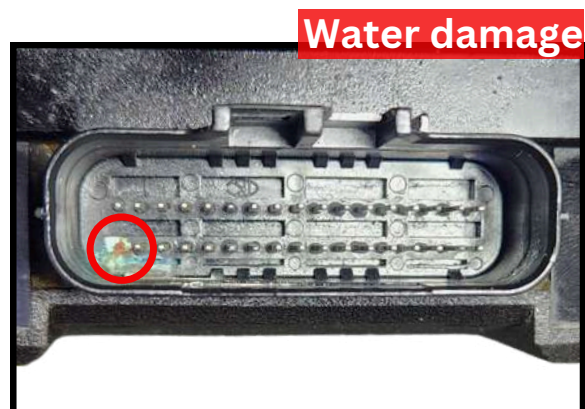
MAIN TORP CONTROLLER CONNECTOR

Check all the pins on the main Torp controller connector carefully to ensure that water breach hasn't caused any pins to corrode or break off as shown below:

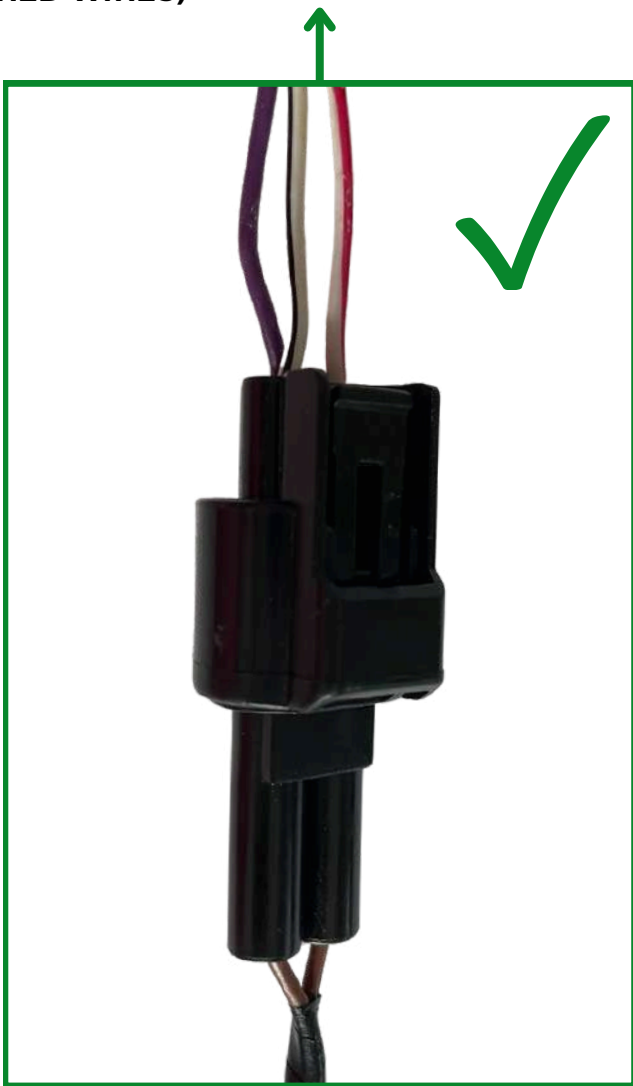
If you're experiencing battery communication error, the 3-pin battery communication connector with two wires on the Torp wiring is not properly connected or the connection is loose, please see the photo below to make sure it's properly installed.

**SURRON SIDE 3-PIN CONNECTOR
(PURPLE, WHITE-BLACK AND WHITE-
RED WIRES)**

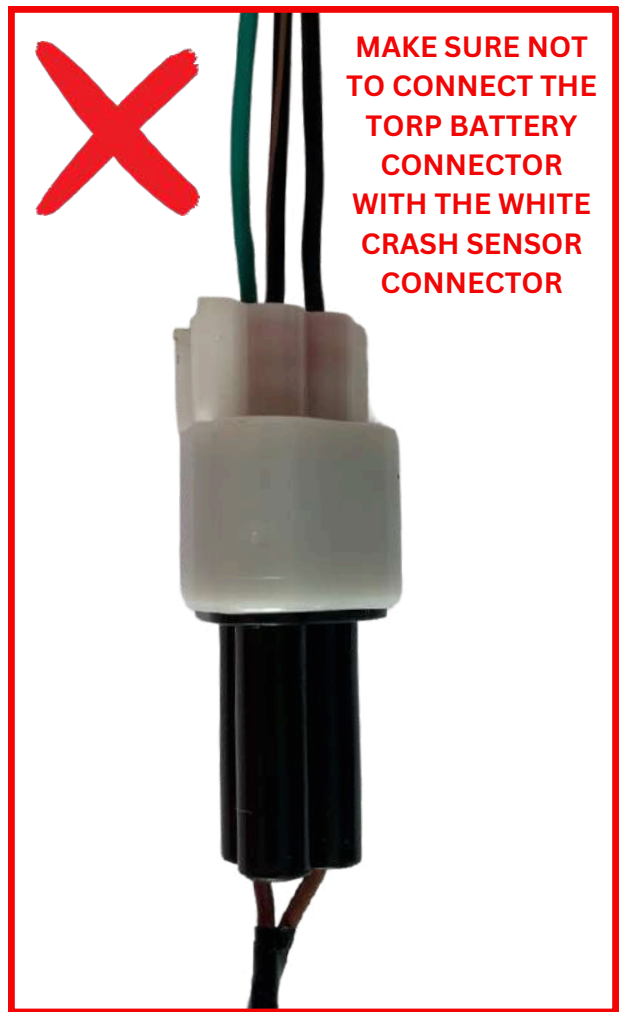
**TORP 3-PIN CONNECTOR WITH TWO
WIRES**
